# FINAL PRELIMINARY ENGINEERING REPORT - WATER SYSTEM IMPROVEMENTS

CHUPADERO WATER - SEWAGE CORPORATION  
SANTA FE COUNTY, NEW MEXICO

Martin/Martin, Inc. Project No.: 17.1400

April 2018

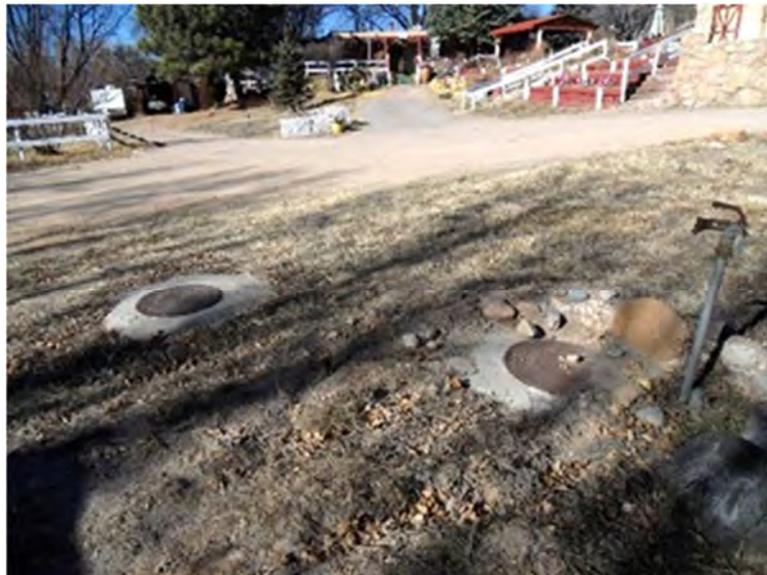
*Photograph 1: Wells #2 and #4*

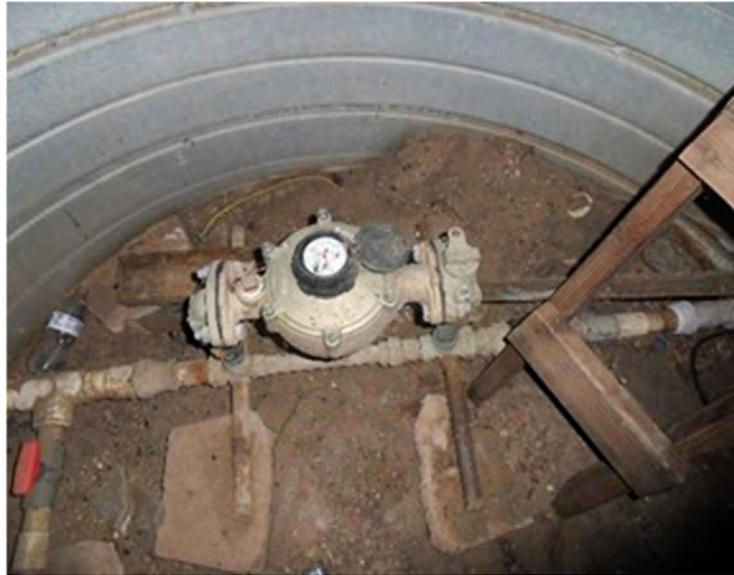
*Photograph 2: Wells #2 and #4 Master Meter*

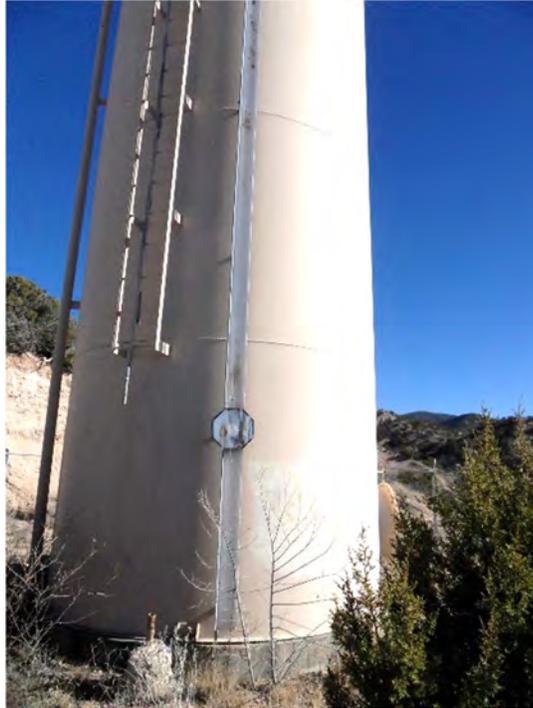
The exterior of the tank appears in good condition. The tank does not have adequate fall protection, does not have a locking ladder access hatch, does not have markings for its external level reader, and the security fence is only partially constructed and does not completely encircle the tank. The

*Photograph 3: Water Storage Tank*

The easement for the existing storage tank site and access road needs to be finalized and executed for this alternative. The existing 20,000 gal. storage tank will be rehabilitated by sandblasting and re-painting the interior and by adding a safety cage with improved fall protection apparatus to the exterior ladder. The offsite matching 20,000 gal. storage tank would be refurbished, transported and erected on the site beside the existing tank. A new 20,000 gal. matching tank will be purchased and erected at the tank site. Two new ring foundations, set at the same elevation as the existing tank foundation, will be required for the two new tanks. A geotechnical study will be required for the new tank foundations. The tank site and access road will be regraded to remove vegetation and to control stormwater and erosion. A rip rap stormwater swale will be constructed on the north side of the access

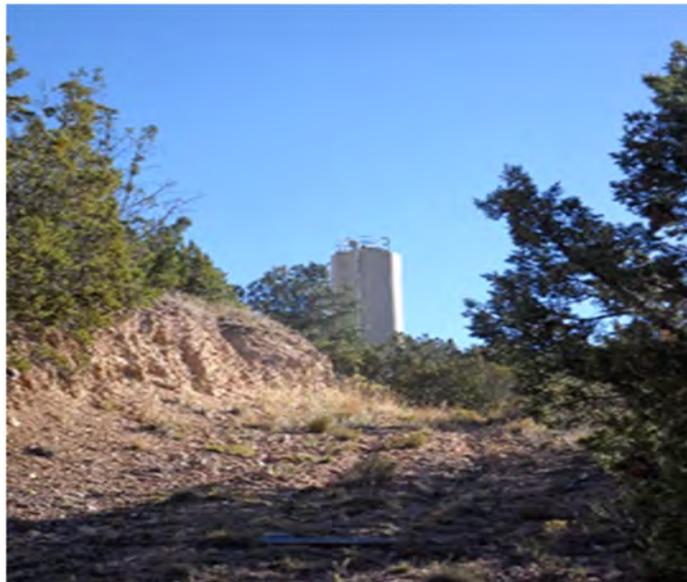
*Photograph 4: Tank Access Road*

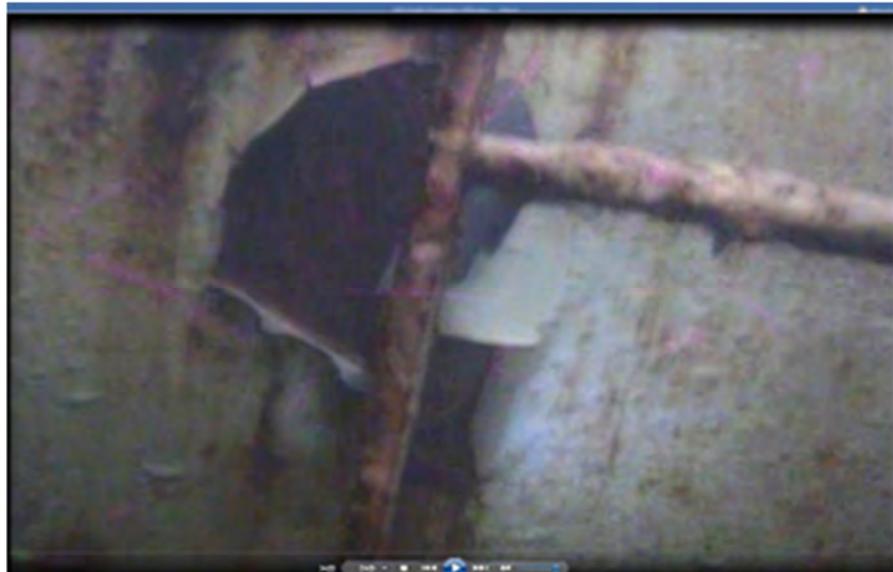
Chupadero provided a video of an internal tank inspection conducted by Inland Potable Services, Colorado. Chupadero thinks the inspection was over 10 years old. The tank inspection video viewed by Martin/Martin, Inc. indicates that the paint on the inside of the tank is peeling off in multiple places, there is some corrosion and rust spots on the floors and walls and paint “blisters” were visible on the tank floor. Select photographs of the video are provided below.

*Photograph 6: Old Tank Inspection Interior Paint*

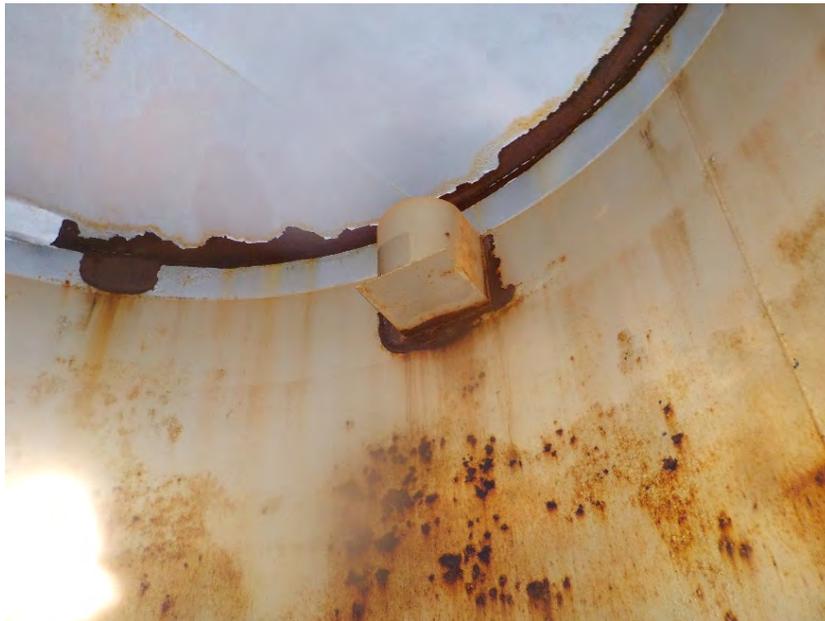
*Photograph 7: New Tank Inspection Interior Ceiling*

- Tank interior requires sandblasting and repainting with NSF 61 approved paint.
- Corrosion is uniform and measurable corrosion not identified therefore interior welding repairs not anticipated.
- Interior ladder has some corrosion that can be repaired by repainting.
- Exterior ladder requires safety cage and improved fall arrest.
- Vegetation around tank foundation should be removed.

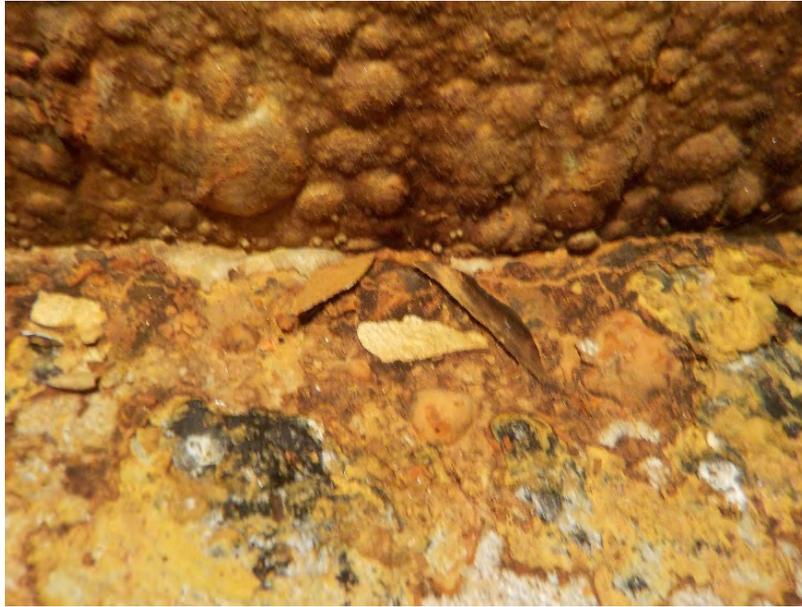
*Photograph 8: New Tank Inspection Interior Wall at Floor*

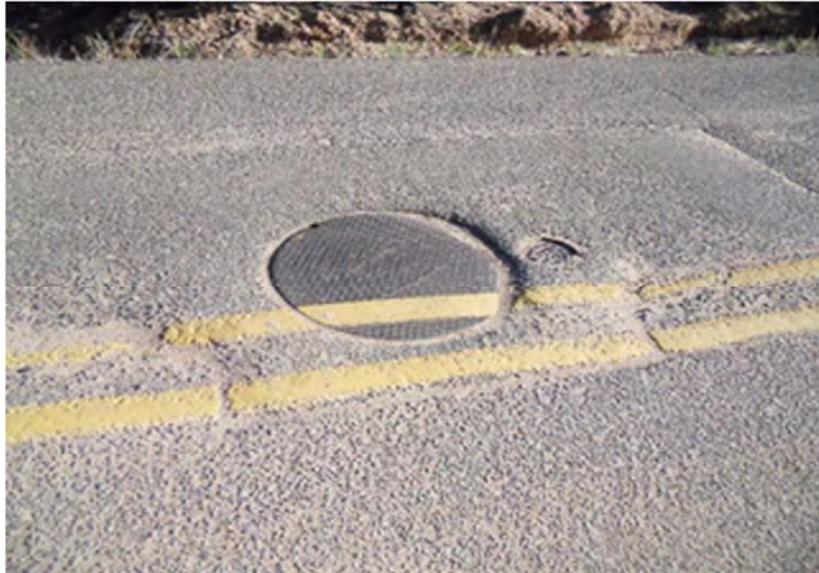
*Photograph 9: Pressure Reducing Valve Station*

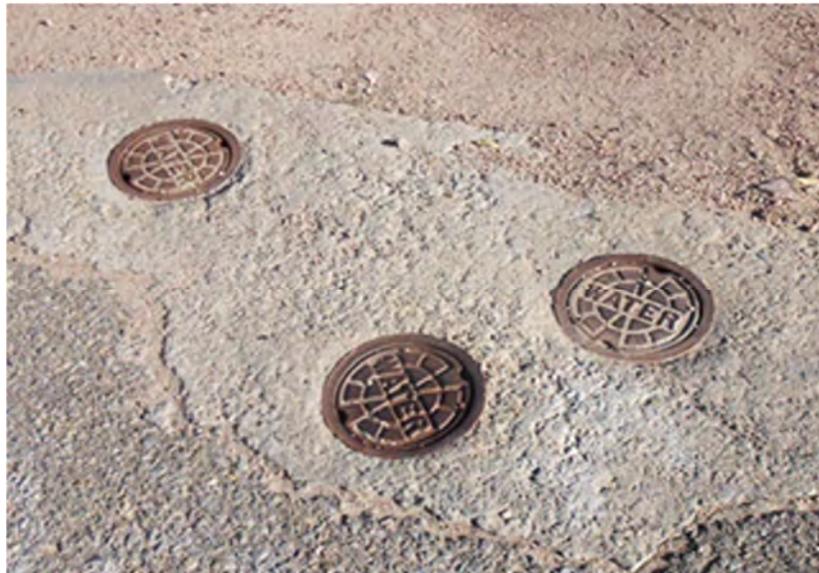
*Photograph 10: Water Main/Lateral Isolation Valves*

The Chupadero water system is over 40 years old. In recent years there have been multiple water leaks and the water system has trouble keeping up with the current needs and demand. Water main isolation valves are leaking and/or inoperable. Based on review of the 10-year-old storage tank video, the storage tank will require interior re-painting and repair of the tank level indicator. Inoperable water service meters were recently replaced as part of a total water service meter replacement project, in collaboration with Santa Fe County. Continual aging of the existing infrastructure over the 20-year PER planning period will most likely increase the level of operation and maintenance required as well as pose greater health and sanitation risks to the community.

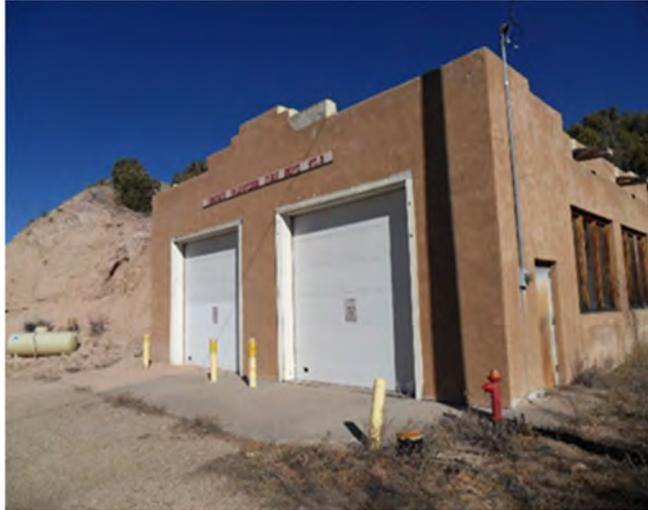
***Photograph 11: Flush Valve at Tesuque Fire Station No. 2***

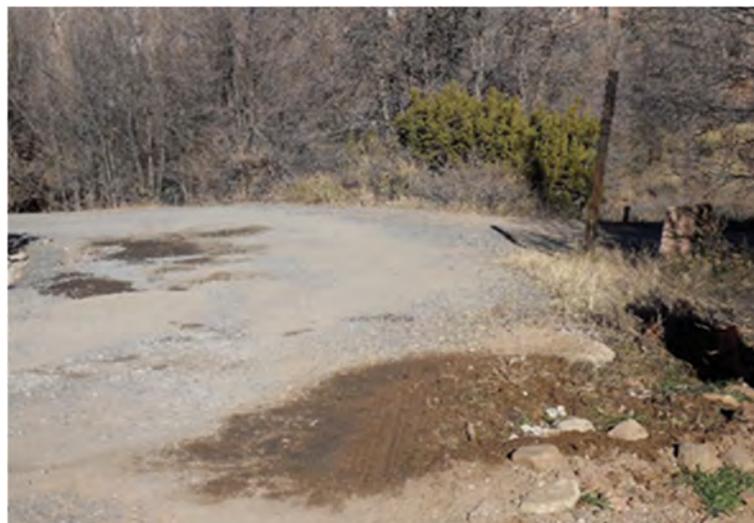
Chupadero has reported a number of leaks occurring in their water main and at some of their isolation valves. An assumed leak (wetted surface extending approximately 20 ft.) was observed by Martin/Martin, Inc. on Camino de Pastores Road during the field reconnaissance conducted on December 27, 2017. Chupadero has also reported that there may be as many as 10 illegal connections and laterals on their water main.

***Photograph 12: Observed Apparent Leak on Camino de Pastores***

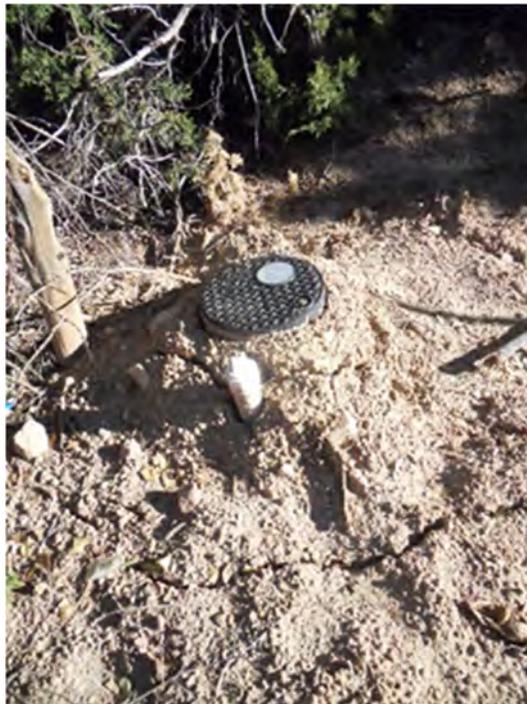
Chupadero recently replaced old water meters with new radio read meters. There are still four service meters that require installation as the service lines have not yet been found. Chupadero has been using a set monthly rate for customer billing and in 2018 will implement a new service rate schedule based on metered flows. A photograph of one of the new water meters is provided below.

*Photograph 13: New Water Service Meter*

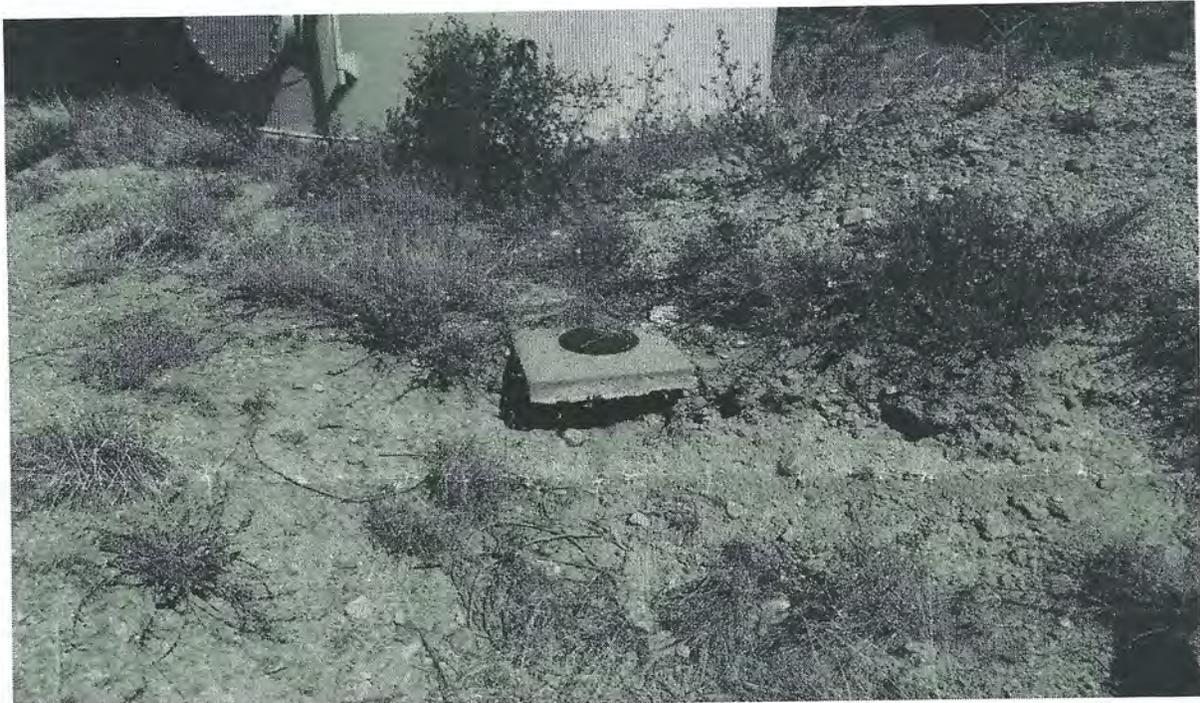
Concern/Description: **Finished Water Storage.** Erosion of the facility site can result in a collapse of storage facilities which can cause a water outage.

Figure 1. Significant Deficiency #2. Erosion near storage tank facility.

Corrective Action: Implement erosion control measures to mitigate erosion at the storage facility. (See Figures 1 & 2).

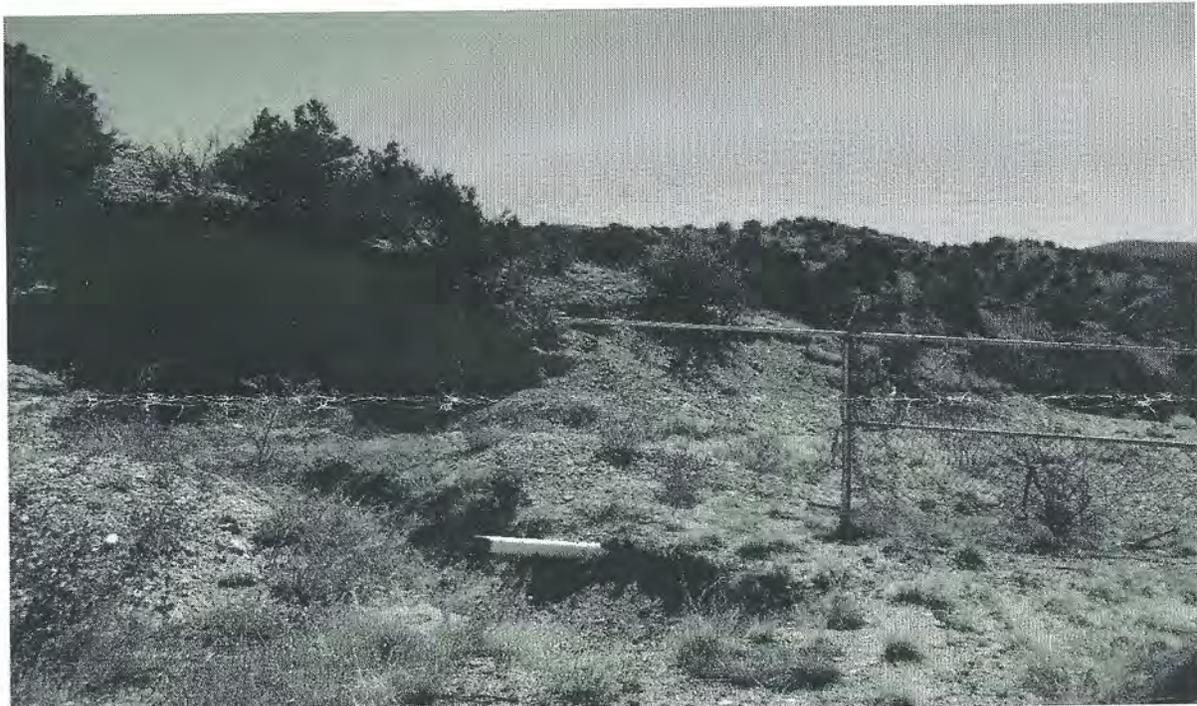
Figure 2. Significant Deficiency #2. Erosion near storage facility.

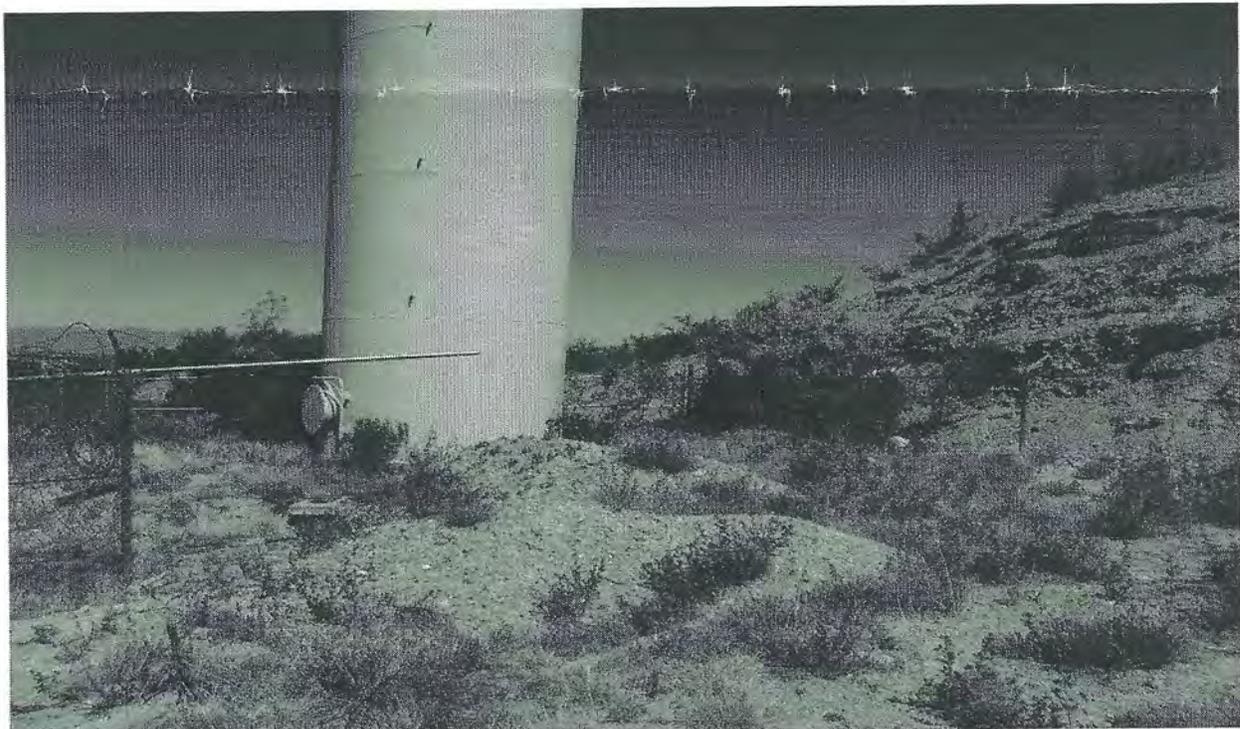
Concern/Description: Unauthorized access can result in water system being contaminate and key components being compromised which could result in a water Outage.

Figure 3. Significant Deficiency #3. Perimeter fence at storage tank is down.

Corrective Action: Reinstall/repair breaks in the perimeter fence around the storage tank.  
(See Figure 3)

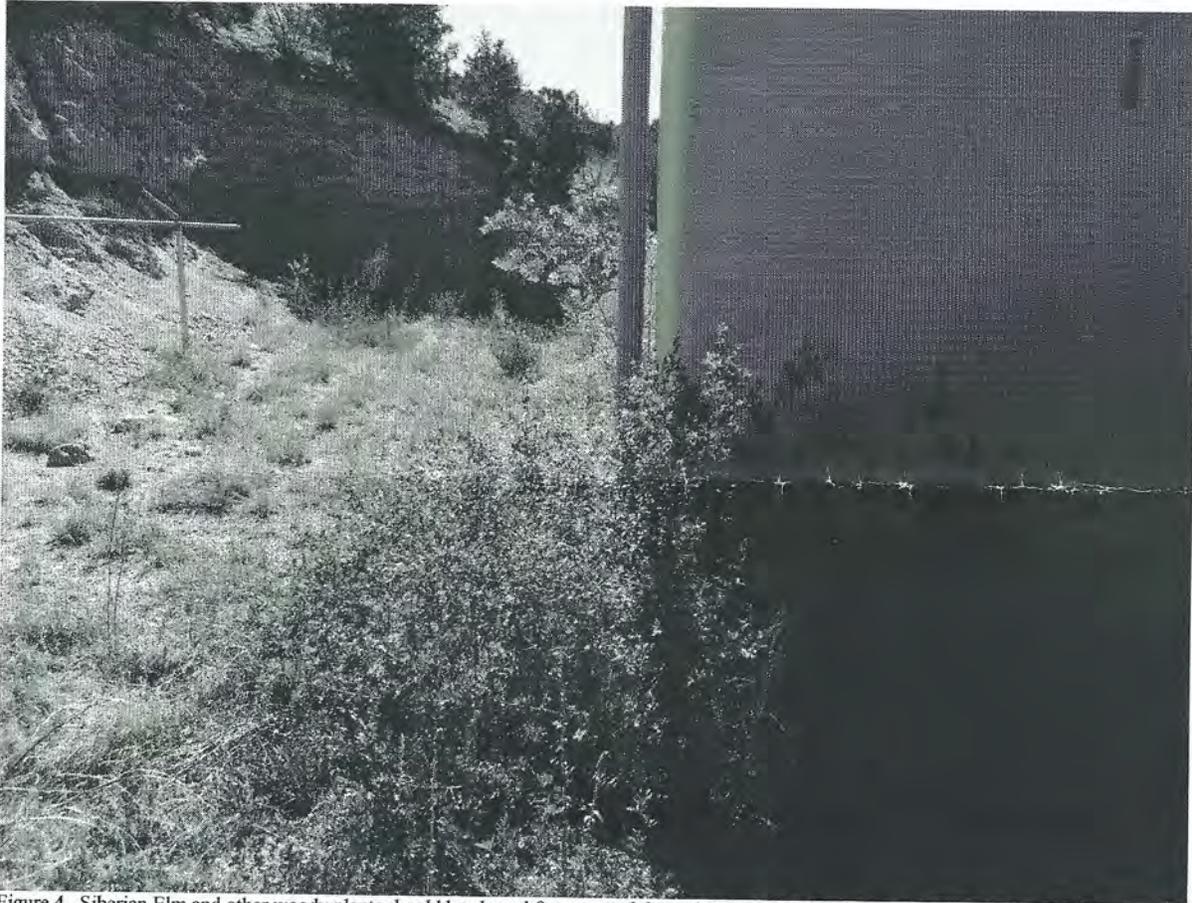
**1. Deficiency:** Brush Growing Around Foundation of Storage Tank

Figure 4. Siberian Elm and other woody plants should be cleared from around the tank to maintain the structural integrity of the facility.

Recommendation: Remove vegetation (Siberian Elm) from around the storage tank. Vegetation could compromise the integrity of the tank foundation and the tank. See Figure 4.
